Manhole Inspection Summary

Manhole # S02YY1005MH

Location Address: **3611 Fords Ln**

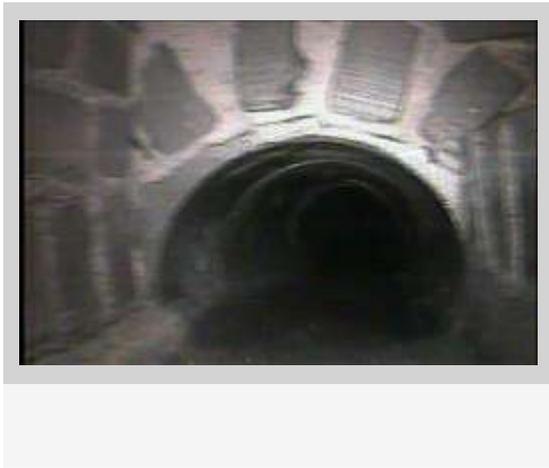
10 in. Circular Gravity Sewer
Pipe Out @ 12 O'Clock

Pipe Material: **Clay** Pipe Lined

Invert Depth: **8.27** (ft.) Flow Characteristics: **Fast**

Infiltration: **None** Pipe Seal Cond: **Sound**

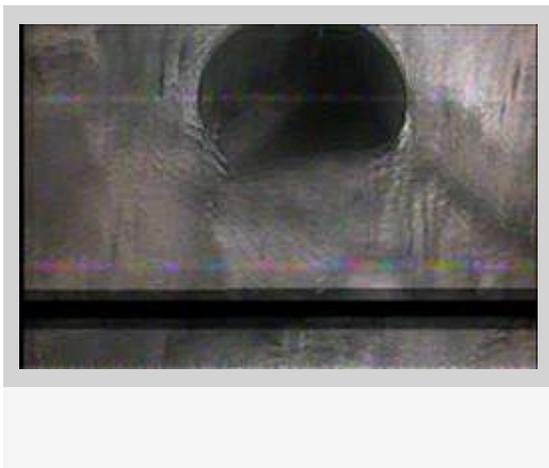
8 in. Circular Gravity Sewer
Pipe In @ 3 O'Clock

Pipe Material: **Clay** Pipe Lined

Invert Depth: **8.00** (ft.) Flow Characteristics: **Slow**

Infiltration: **None** Pipe Seal Cond: **Sound**

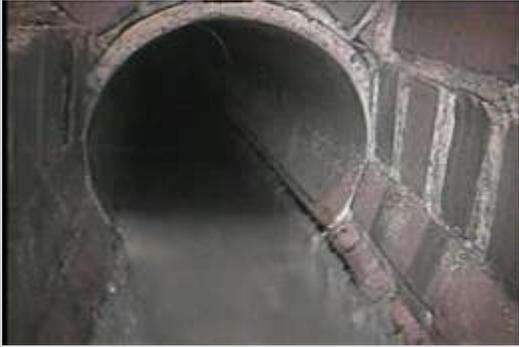
Pipe In @ 6 O'Clock

Pipe Material: **Clay** Pipe Lined

Invert Depth: **8.22** (ft.) Flow Characteristics: **Fast**

Infiltration: **None** Pipe Seal Cond: **Sound**
